Behaviour of epoxy filled flat-face joints in concrete for wave energy converters

A thesis presented in application for the Degree of Doctor of Philosophy
Division of Civil Engineering
University of Dundee
2018

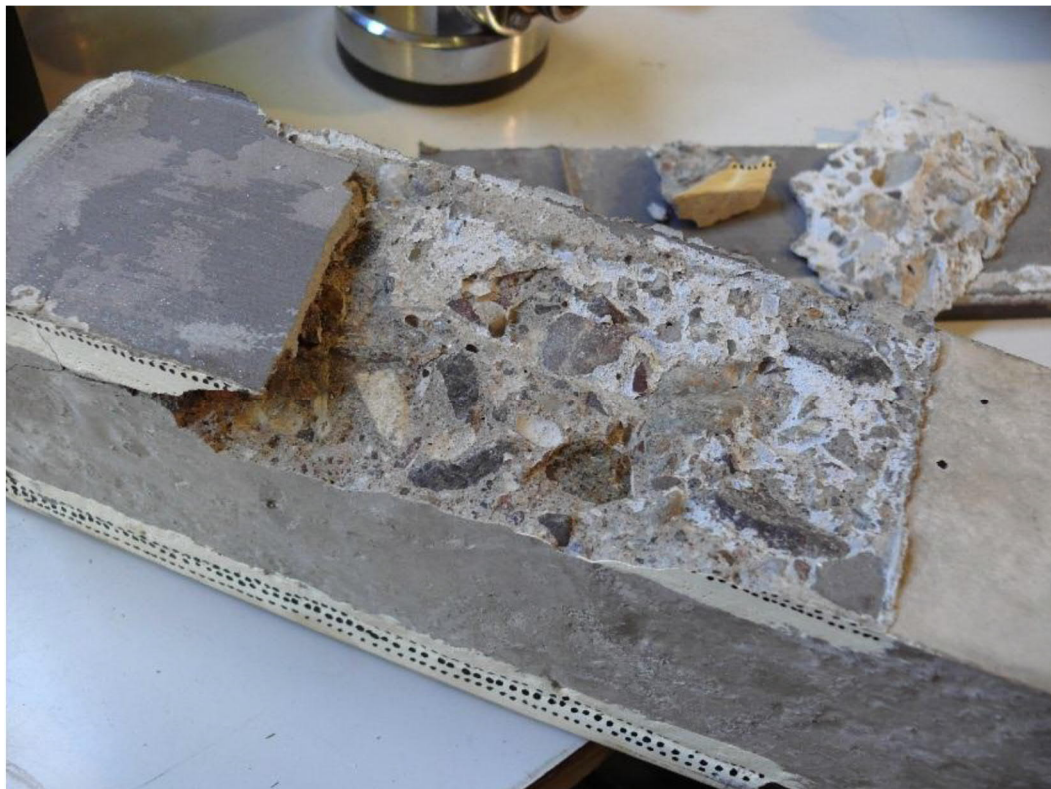
Figure 4.21. Failure mode of bonded fresh concrete to steel

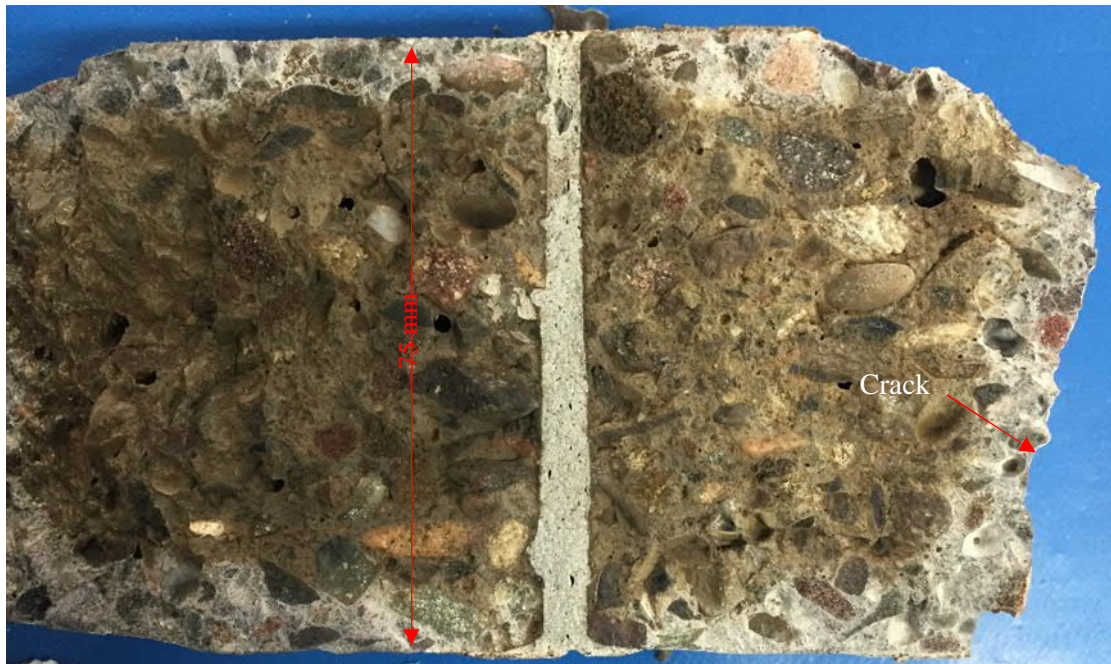
Figure 6.23. AgNO_3 spraying for determining chloride ingress depth for sample E (Cyclic load condition)
